# LIMITED CONTAMINATION ASSESSMENT

(AIRBORNE FUNGAL EVALUATION)

[FULL PROPERTY ADDRESS]

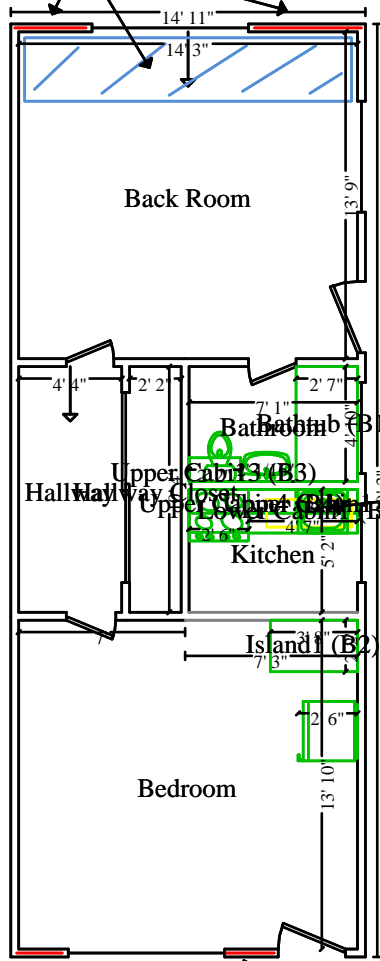
Affected Tile Floor & Wall
